## THE CHALLENGE

## BEFORE: HEAT EXCHANGER SPECIFICATIONS

## THE SOLUTION

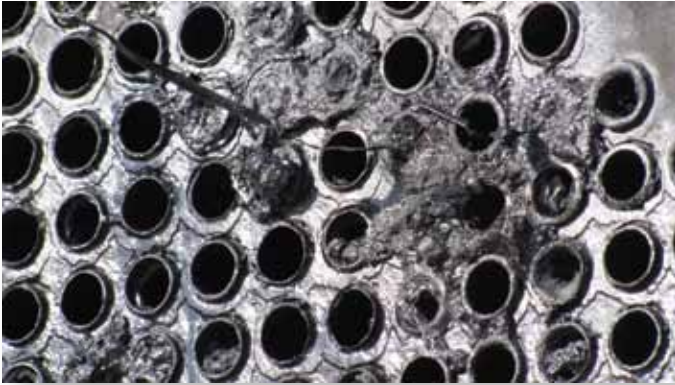
This heat exchanger had a combination of bitumen and coke on the tube side and process steam on the shell side. The client confirmed this type of fouling typically took 8-11 days to clean. Thousand of gallons of water was used to remove this type of fouling with limited success. There was limited water capacity onsite which caused an additional logistical constraint.

Over 25% of the exchanger was completely plugged with coke. This combination of fouling is difficult to clean to the binding. Current methods were hazardous and labour intensive.

ABSOLUTE's processes set a new standard previously never achieved before by safely removing 3,500 lbs of fouling in record time. The heat exchanger was cleaned and passed full inspection within 36 hours, which is 63% faster than their current provider.

Phase 1 removed all bitumen fouling. This was completed within 12 hours. We engaged a 3rd party to carry out the second phase which required minimal high pressure water, which was contained and recycled. This was completed within 24 hours.

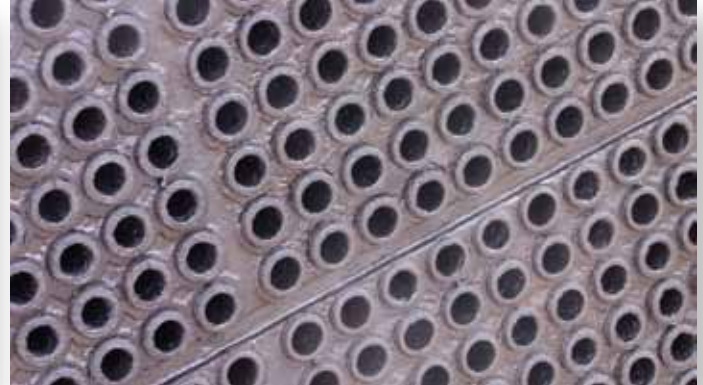
Fouling Removed: 3,500 lbs

Return Weight: 38,000 lbs
