“Brass of Gold”

Straight Tube Heat Exchanger

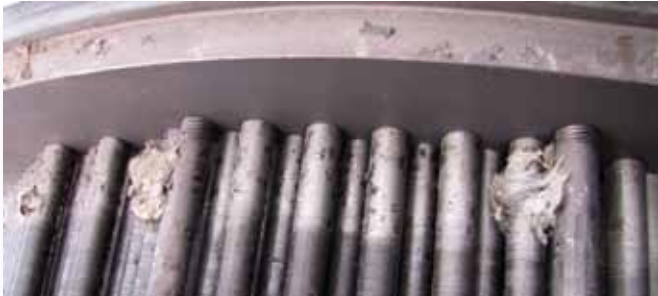
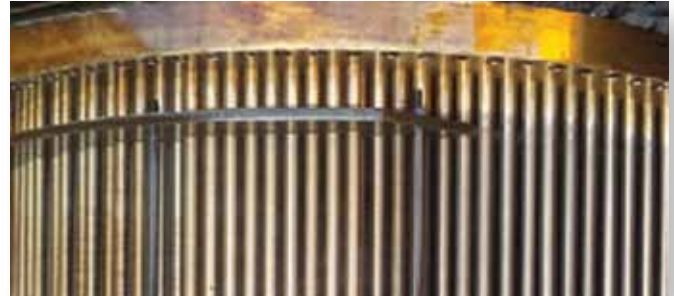
Brass finned exchangers are very difficult to clean due to the binding agent collecting in small fins, trapping in the foulant. Conventional high pressure water blasting increases the risk of tube and fin damage.

We were required to remove the hydrocarbon fouling from the shell side while not damaging the expensive brass finned tubes.

First, we tested and verified material composition to ensure compatibility with our process and solvent. The exchanger was lowered on to our fully supported and controlled roller system in our cleaning chamber and submerged in our safe proprietary solvent.

In a short 8 hours, the exchanger was removed for inspection.

Fouling Removed: 1,500 lbs
