## THE CHALLENGE

## BEFORE: HEAT EXCHANGER SPECIFICATIONS

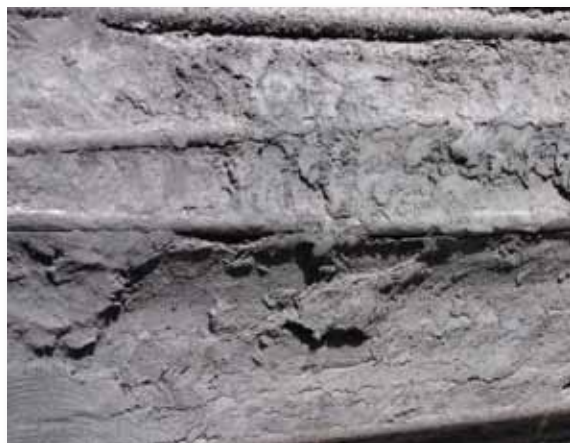
The extent of fouling was extreme on the shell side and included significant coking on the tube side. This was due to an uncontrolled shutdown with an operational process upset which overloaded the exchanger exceeding five times the normal levels of fouling.

Type of Asset: Heat Exchanger

Material: Carbon Steel

Size: 20 feet long, 61" diameter

Arrival Weight: 52,700 lbs

Design: Straight Tube

Fouling / Process: Tube- Heavy Gas Oil / Shell- Gas Oil

# of Tubes: 1460

Outer Tube Dimension: 1"

We used ABSOLUTE'S patent pending process in Phase 1 to remove hydrocarbon fouling. This cleaned the shell side fouling and all tubes except the coke plugged tubes. Due to the excessive coke we engaged a 3rd party to carry out the second phase which required minimal high pressure water, which was contained and recycled.

With coke plugs removed the exchanger was given a final rinse in our organic solvent to remove any hydrocarbon trapped behind coke plugs.

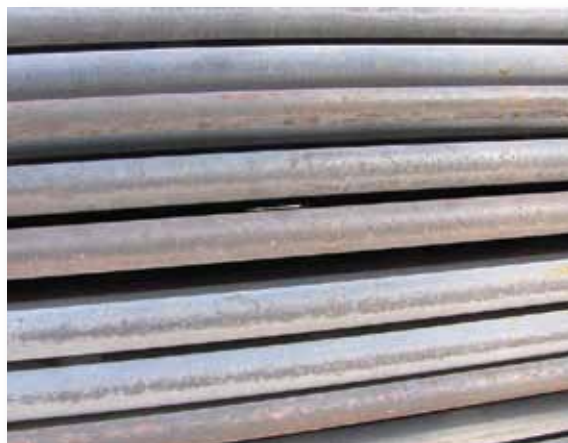
## AFTER: BENEFITS & RESULTS

Fouling Removed: 14,100 lbs

Time Cleaned: 24 hours

Est. Time Saved: 180 man hours

Return Weight: 38,600 lbs

Inspection Standard: Process

- ✓ No water consumed during Phase 1
- ✓ Removed fouling left on from other service providers
