## THE CHALLENGE

## BEFORE: HEAT EXCHANGER SPECIFICATIONS

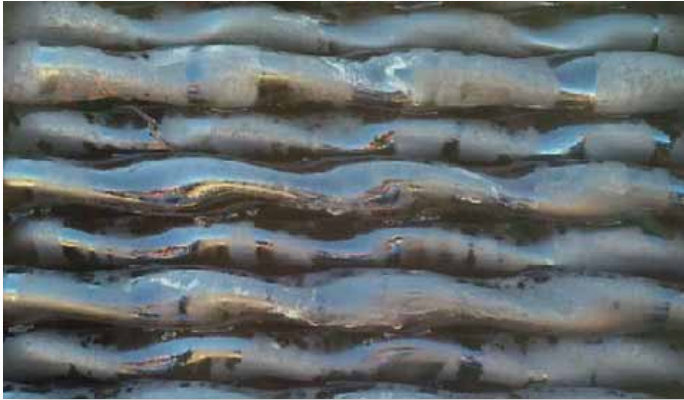
Twisted tube designed heat exchangers are exceptionally difficult to clean. This particular fouling process is extra challenging due to the steam in the tube side which bakes the bitumen on to the shell side faster than other designs.

This heat exchanger was brought to ABSOLUTE after a previous service provider was not successful in their attempt to clean it. When previously cleaned and left out in warm ambient temperatures, the remaining bitumen left in the core would leak from the inner core.

Fouling / Process: Tube- Steam / Shell- Bitumen

ABSOLUTE submerged the exchanger in our proprietary solvent for 6 hours. Not consuming any water and using no harsh chemicals that required deep-well disposal after, this bundle came out shiny and clean.

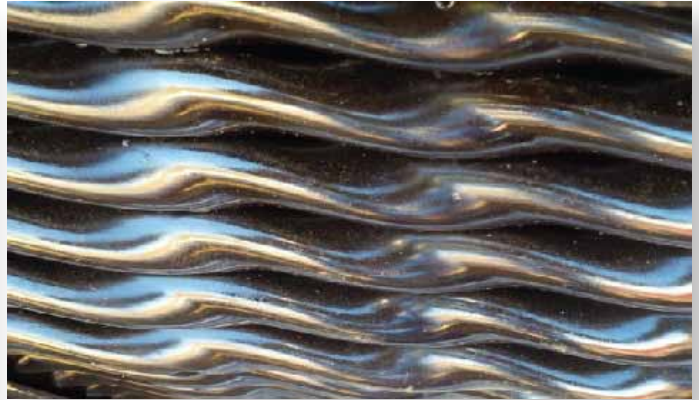
## AFTER: BENEFITS & RESULTS

We removed the exchanger from the solvent and let it sit in the sun over a period of time to see if any bitumen was left on the inner core and would run out on to the outer shell. The results showed it was cleaned to the core.

Fouling Removed: 2,000 lbs

Return Weight: 28,000 lbs
