“The Twisted Challenge” Twisted Tube Heat Exchanger

THE CHALLENGE

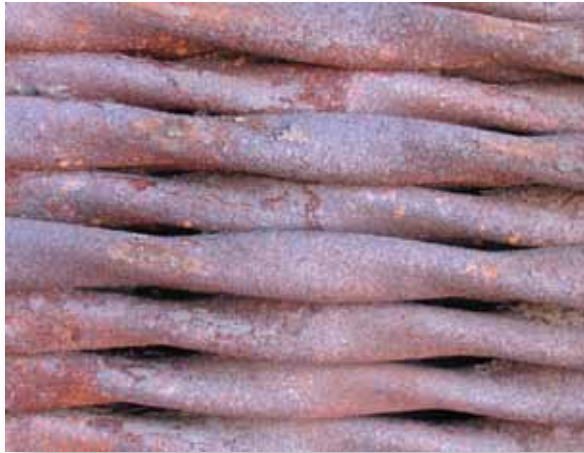
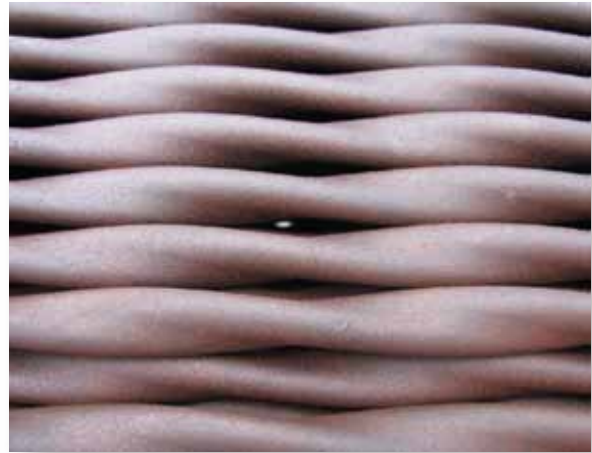
Due to broader surface areas, twisted tube bundles allow greater heat transfer compared to straight tube exchangers, however it becomes fouled more quickly due to the design. Additionally, the twisted tube design makes it very challenging to clean. This type of exchanger was historically required a minimum of 6 days of high pressure water cleaning at 100 litres/ minute.

BEFORE: HEAT EXCHANGER SPECIFICATIONS

Type of Asset: Heat Exchanger

Material: Carbon Steel

Size: 24 feet long, 60” diameter

Arrival Weight: 55,000 lbs

Design: Spiral Tube

Fouling / Process: Tube- Gas Oil / Shell-Gas Oil Pump Around ✓

of Tubes: 2,666 tubes

Outer Tube Dimension: 0.75”

We used our ABSOLUTE patent pending technology to clean the exchanger and engaged a 3rd party to provide an inspection and report. The independent inspection was performed according to the clients direction, partial at 451 tubes, equating to 16.9% coverage.

We returned the asset to operating state, eliminating its disposal. The client was able to reclaim the operating efficiency in heat transfer that these exchangers provide and eliminated phase out costs of their twisted tube bundles.

Fouling Removed: Unknown

Time Cleaned: 24 hours

Est. Time Saved: 120 man hours

Inspection Standard: Eddy Current
